Geophysical Investigations I

Oceanographic Investigations of Bathymetry, Ocean Floor Discharge of Freshwater through the Ocean Floor and Sediment Distribution¹

Oceanographic Investigations of Bathymetry, Ocean Floor Discharge of Freshwater through the Ocean Floor and Sediment Distribution

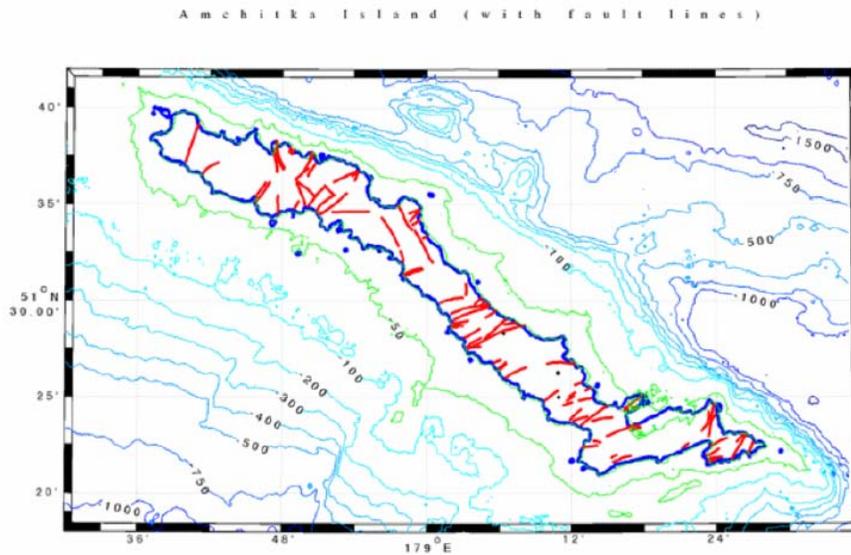
Figure 5.1. Contours of ocean depths, Amchitka Island coastline and geological fault lines.

Evaluation of prior data included completing a literature search related to Amchitka Island, and collection and digitization of geologic charts and maps, bathymetry and aerial photography. A list of available information is provided in Table 5.1, which may be downloaded from either the CRESP (www.cresp.org) or University of Alaska web sites (<http://www.ims.uaf.edu/research/johnson/amchitka/>). Figure 5.1 provides a summary depiction of ocean depths, Amchitka Island's coastline and geologic fault lines. Figure 5.2 indicates the survey lines for aerial photos taken prior to and shortly after the nuclear testing.

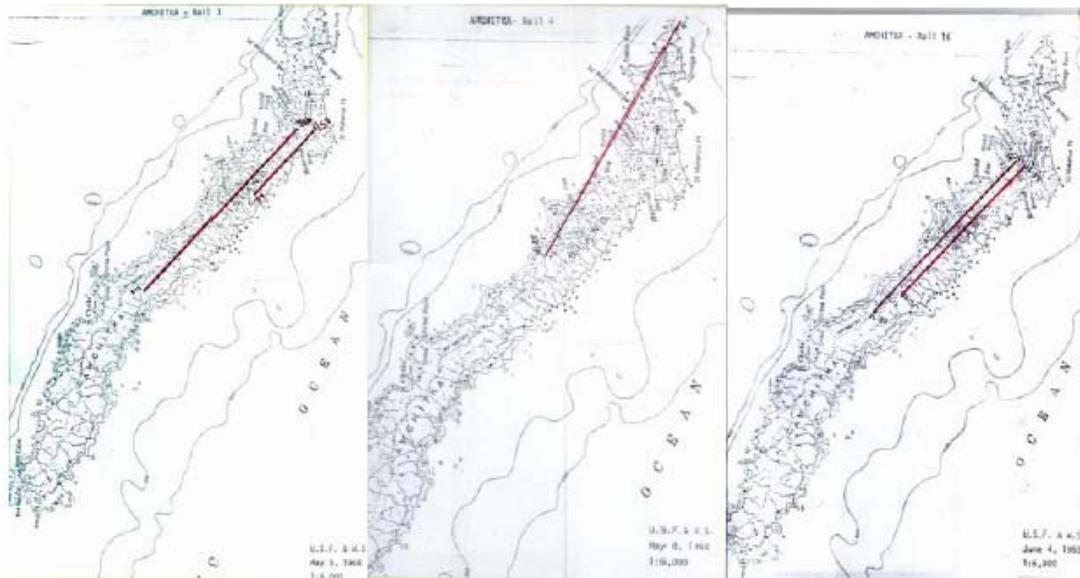
Figure 5.2. Scanned images of survey lines for aerial photos taken prior to and shortly after nuclear testing over southeastern Amchitka Island. Photos are archived at the University of Alaska Fairbanks.

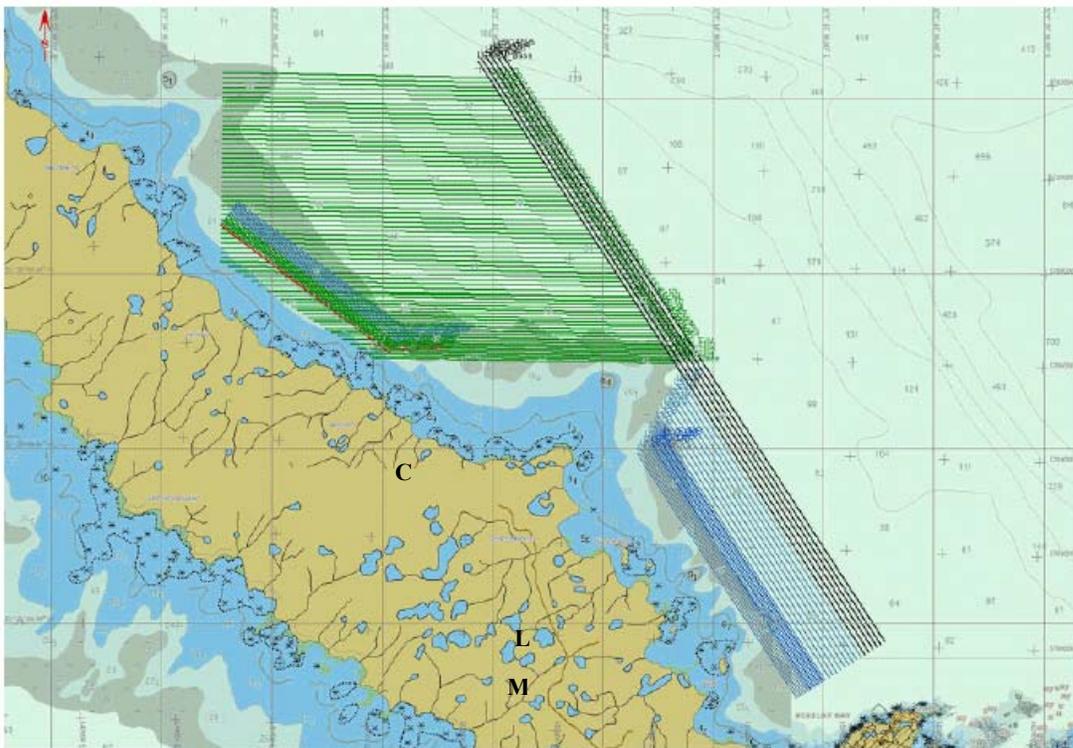
Figure 5.3. Survey lines for bathymetric survey. Approximate locations of test sites are shown.

The bathymetry to the north of Amchitka Island from about 20 m depth to the 100 m isobath offshore of the *Cannikin* and *Long Shot* test sites was mapped to 2 m resolution using a multibeam echosounder (SM2000). The SM 2000 multibeam echosounder has a range scale of 400 meters, interrogated the bottom at 1.92 pings per second, with receiver gain at 35%. For the multibeam data post processing, the QINSy processing module (Validator) was used to visually inspect each multibeam survey transect for data anomalies. The bathymetry data were de-tided and then mapped onto a 2 m grid. The final validated and de-tided points were then exported into ASCII XYZ data files for merging and gridding with Fledermaus, a 3D data viewer, or other software. The survey transects and resulting bathymetry are provided in Figures 5.3 and 5.44, respectively. Data files of the bathymetry (in ascii) are available at CRESP (www.CRESP.org) and University of Alaska web sites (<http://www.ims.uaf.edu/research/johnson/amchitka/>).

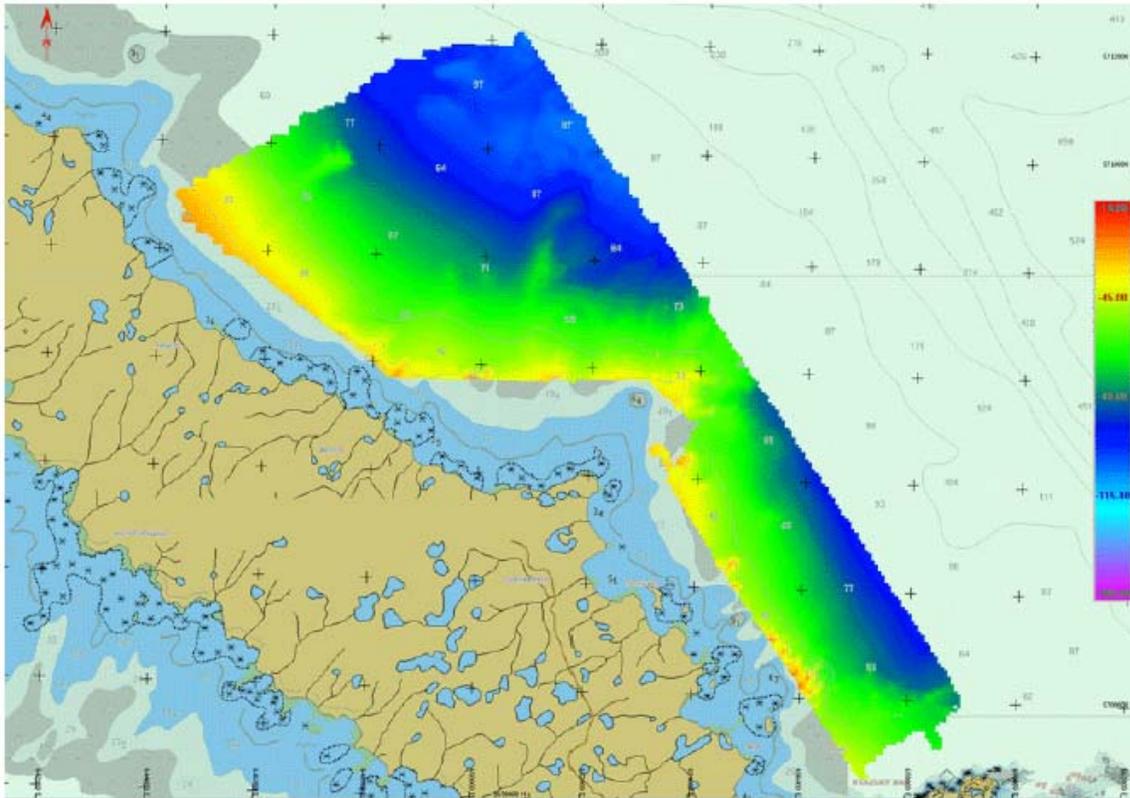
Figure 5.4. Contours of bathymetry from this study. For approximate locations of *Cannikin* (C), *Long Shot* (L) and *Milrow* (M) see Figure 5.3

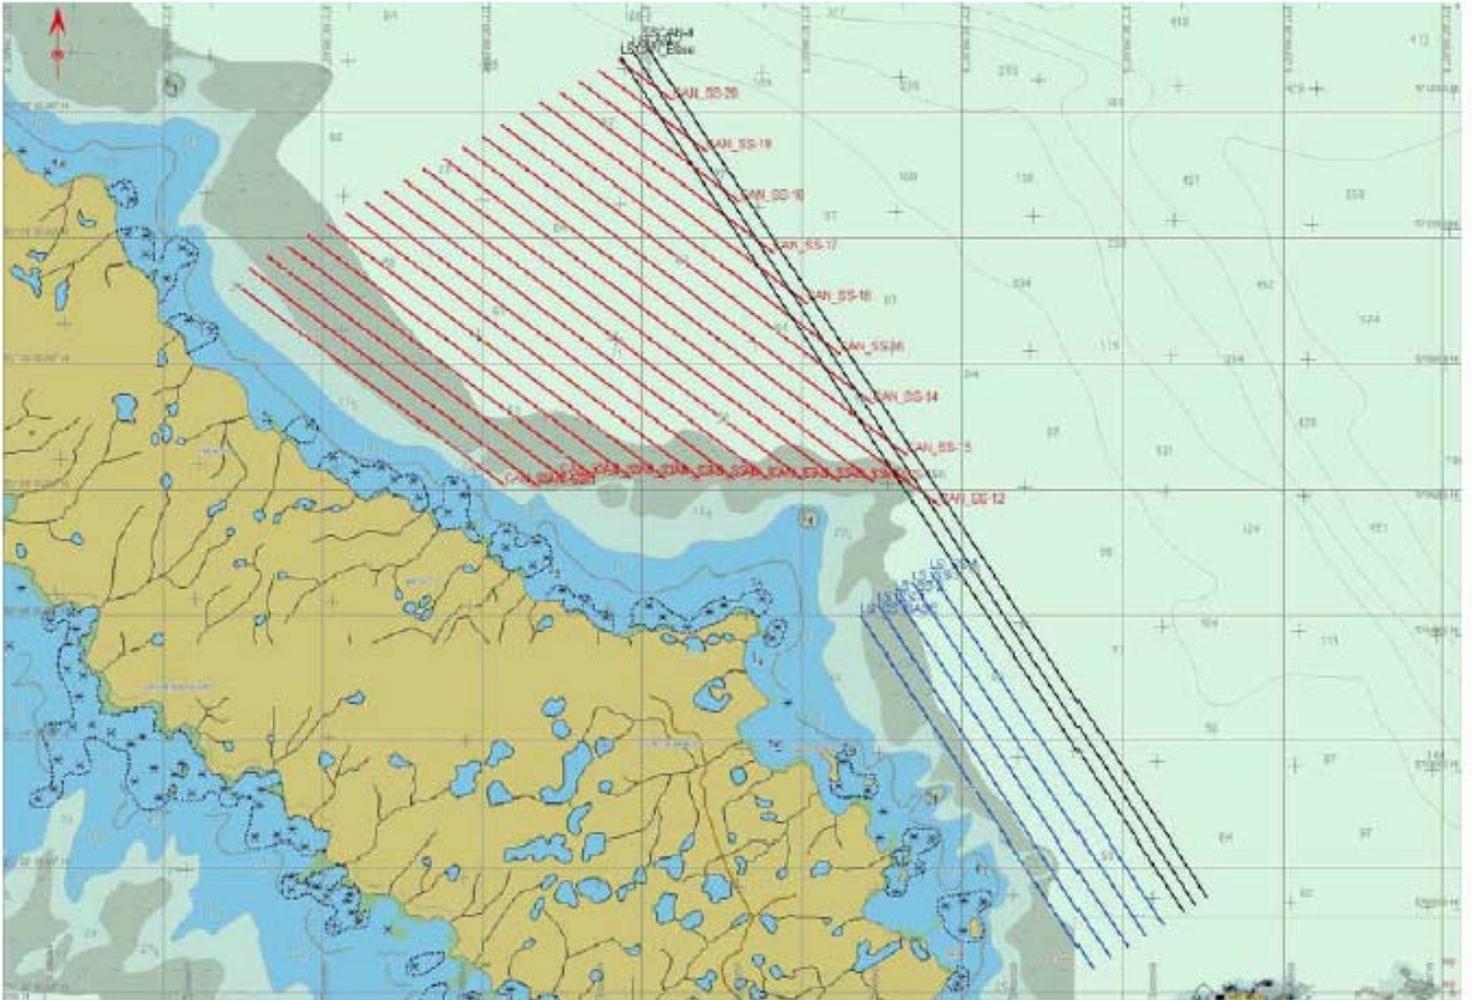
Figure 5.5. Transect lines for the side scan survey. For approximate locations of *Cannikin* (C), *Long Shot* (L) and *Milrow* (M) see Figure 5.3

A Datasonics SIS 1000 sidescan sonar was used to map the bottom over the region of the bathymetry survey. The bathymetry survey was a prerequisite to ensure knowledge of the bottom so the sonar could be towed safely. It has a range scale of 200 meters which produces a 400 meter swath width. The survey transects and resulting sidescan sonar image are provided in Figures 5.5 and 5.6, respectively. Data files of the sidescan sonar (as jpeg images) are available at CRESP (www.CRESP.org) and University of Alaska web sites (<http://www.ims.uaf.edu/research/johnson/amchitka/>). Dark shaded areas indicate the presence of sediment deposits. Locations where sediment samples were obtained are indicated in Figure 5.7. Both fine and coarse grained sediment samples were retrieved and varied by location. Program resources did not permit characterization of these sediments for inclusion in this report.

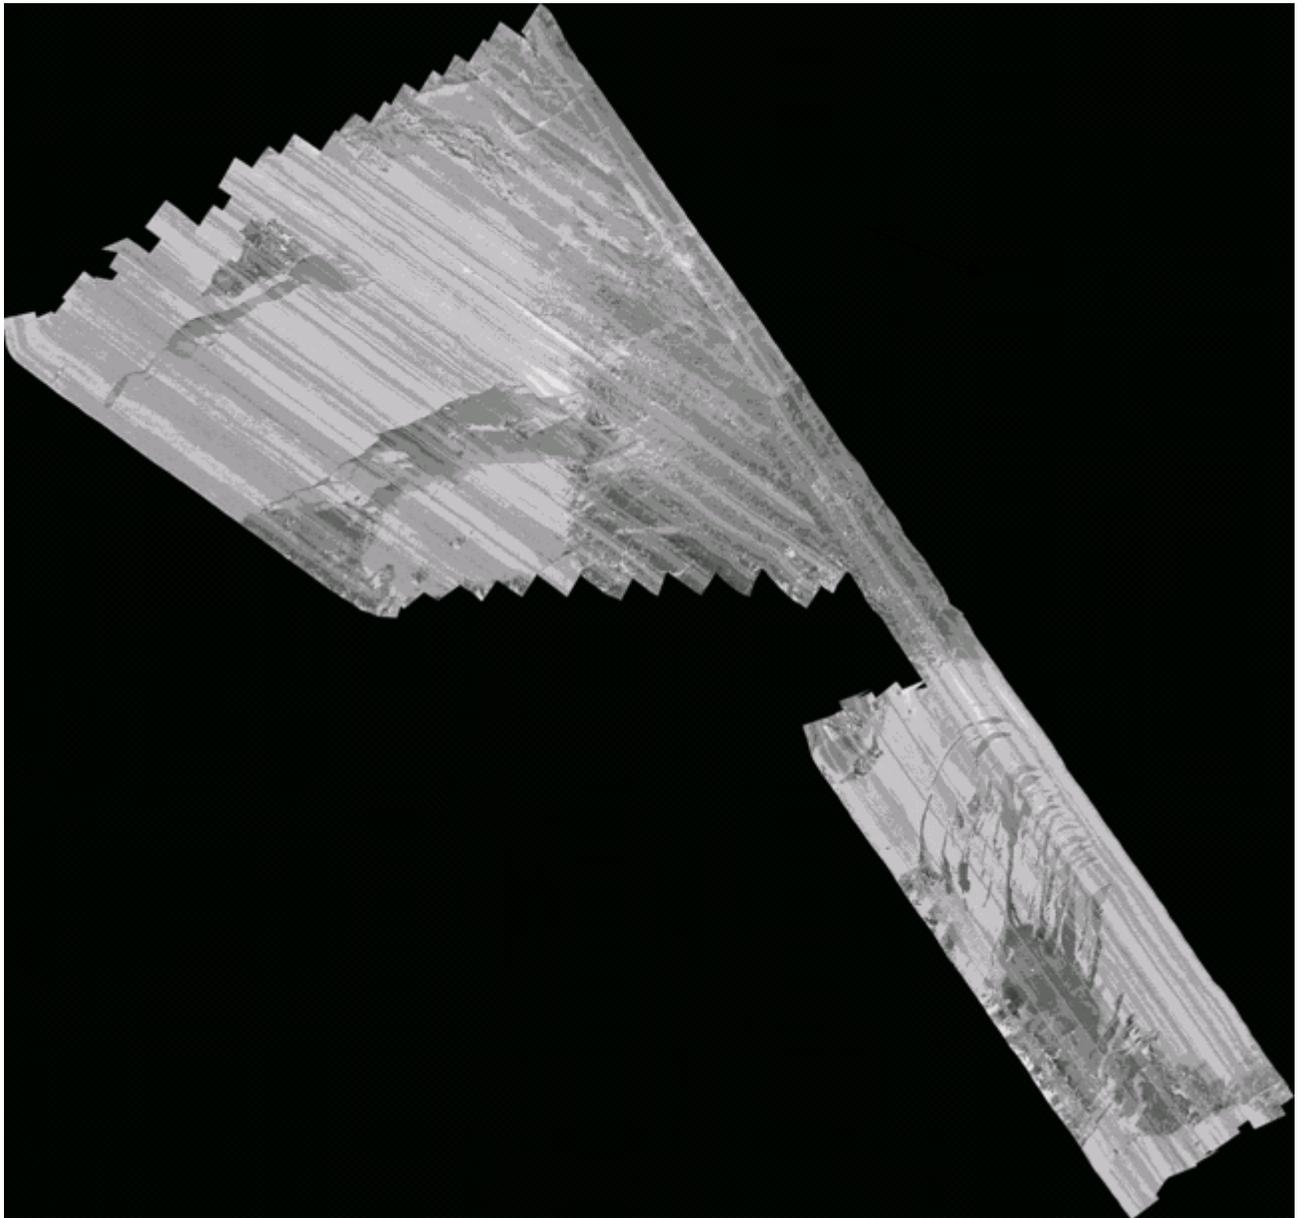
Figure 5.6. Side scan mosaic of all transect data. Note regions of apparent slumping offshore from the *Cannikin* site in the upper part of the frame, and almost parallel, curvilinear features off *Long Shot*. Benthic sites selected for the grab samples were based on this mosaic,

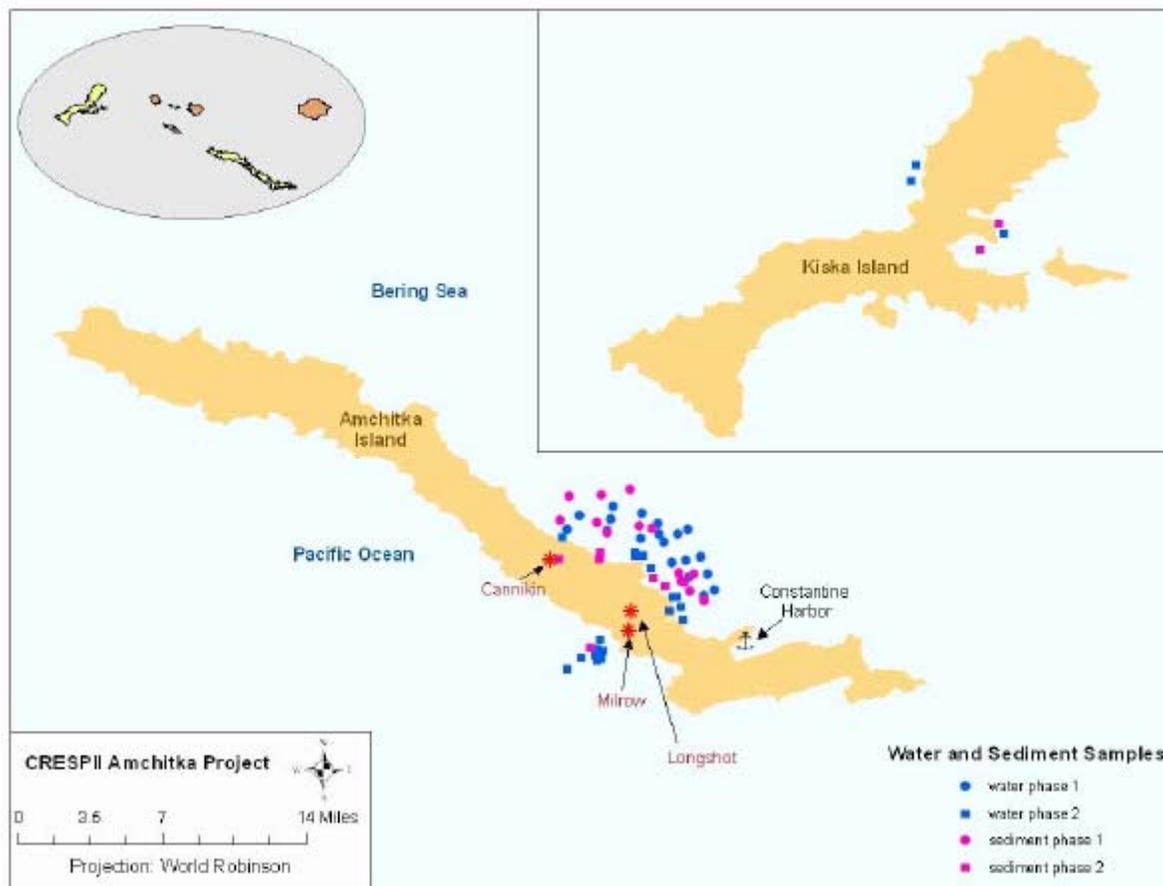
Figure 5.7. Locations of water (Niskin bottle) and sediment samples.

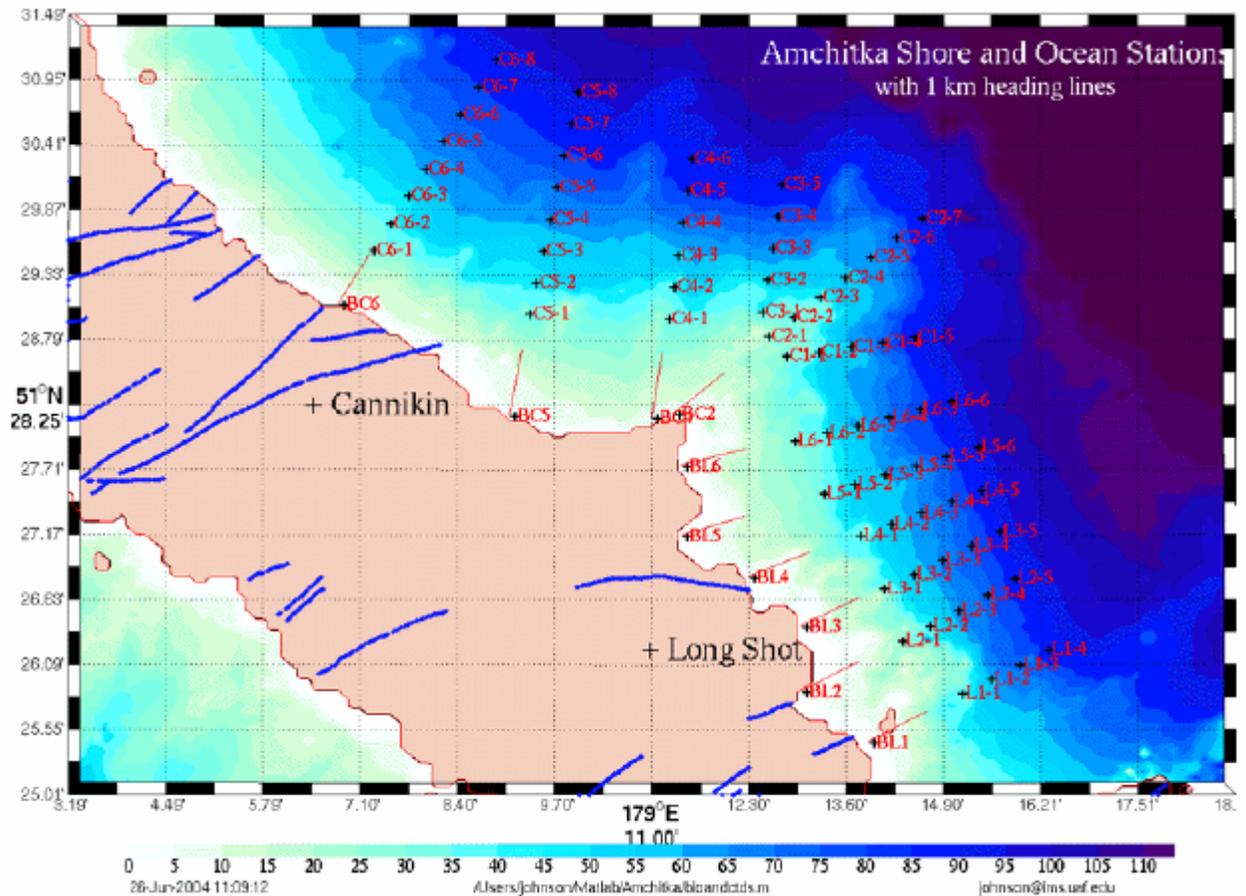
Figure 5.8. Sampling lines and CTD station locations. Blue lines over land show fault lines from historical maps as discussed above. *Cannikin* and *Long Shot* sites are shown. Stations near shore with heading location for sampling by divers are also shown.

Following the bathymetry and sidescan surveys, eighty oceanographic stations along twelve (12) transects running perpendicular to the bathymetric slope were occupied using a SeaBird 19 CTD (<http://www.seabird.com/>) to measure conductivity (salinity), temperature, and pressure (depth). The CTD was calibrated by Sea-Bird Electronics, Inc both before and after the cruise. Resulting salinity accuracy is about 0.001. Resulting temperature accuracy is about 0.01⁰C. The CTD was lowered at no more than 30 m per minute until a 1-2 m altitude above bottom was reached, and then the CTD was held at that depth for 2 minutes to measure salinity near the bottom. Adjustments to the depth of the CTD were made in real-time based on variations in the measured altitude using an acoustic altimeter attached to the CTD with shipboard readout. CTD data were collected as 0.5 second averages. The temperature (degrees C) and salinity (dimensionless Practical Salinity Units) were aligned in time with pressure to correct for lags in the sampling stream. The sampling lines with station locations are shown Figure 5.8.

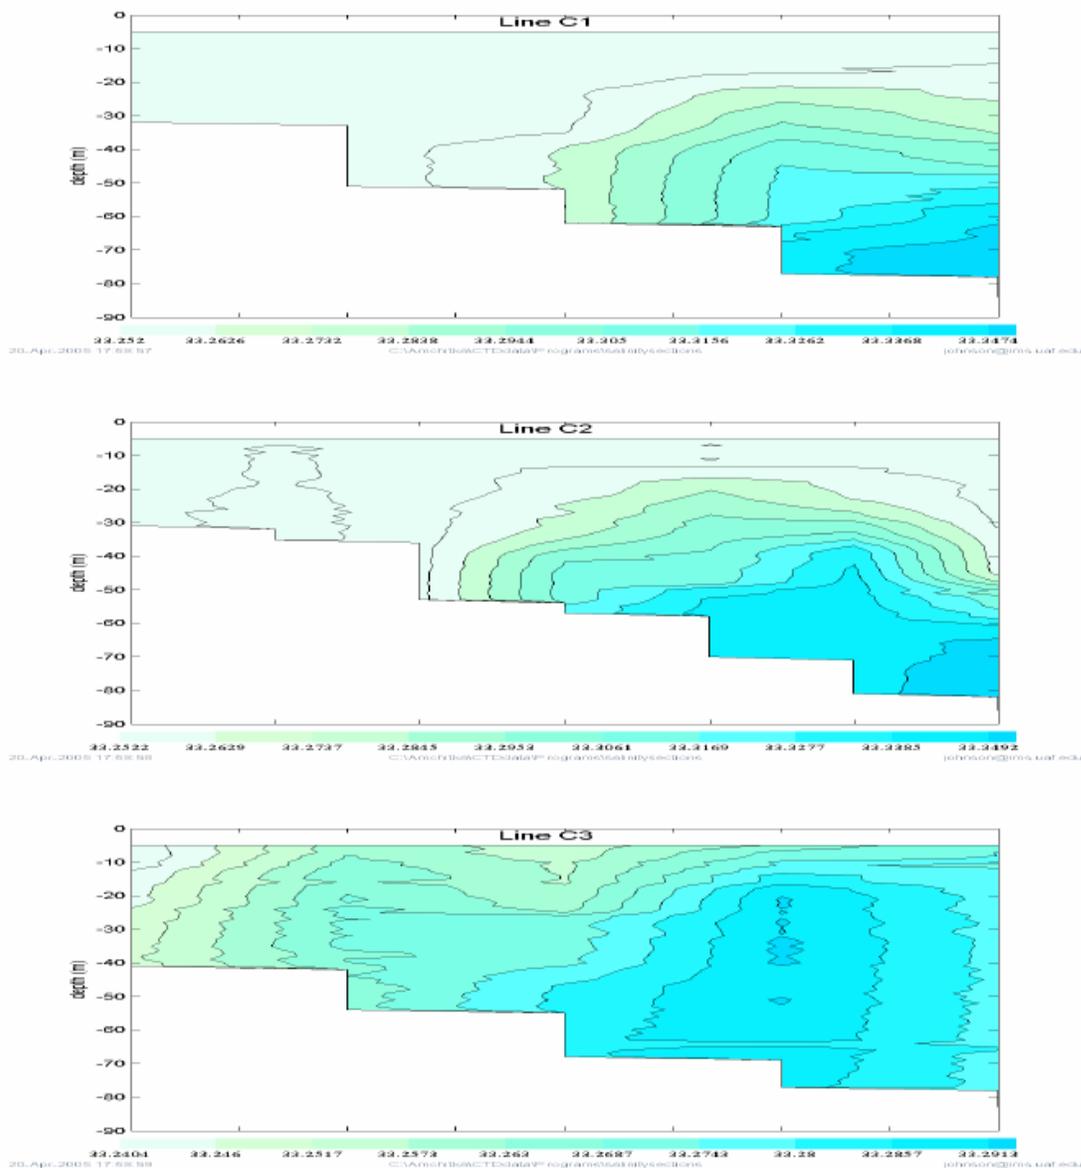
Figure 5.9. Typical vertical sections of salinity (along Lines C-1, C-2, C-3 from Figure 5.8). The section label is shown at the top and depth (meters) is at the left. Offshore is to the right. Note that the salinity scale changes for each section for better visualization. Generally, salty water intrudes onto the shallow shelf from offshore.

Salinity data along the above transect lines, from L1 – L6 and from C1 – C6 were contoured as vertical sections. Three typical sections are provided as Figure 5.9; additional sections are provided in Appendix 5.A Each transect took several hours to complete, so the tidal signal is marginally aliased along each individual section. Each section can be viewed as a nearly synoptic snapshot of the ocean conditions at that time. Multiple sections took longer, so comparing sections introduces aliasing of the tidal signal. These vertical sections show no obvious evidence of broadly distributed freshwater at the bottom.
